## **COMMUNITY FLOOD ASSESSMENT** WHAT IS AT RISK IN FISCAL YEAR 2021?

# **COUNCIL DISTRICT 1: FISCAL YEAR 2021 COMMUNITY FLOOD ASSESSMENT**

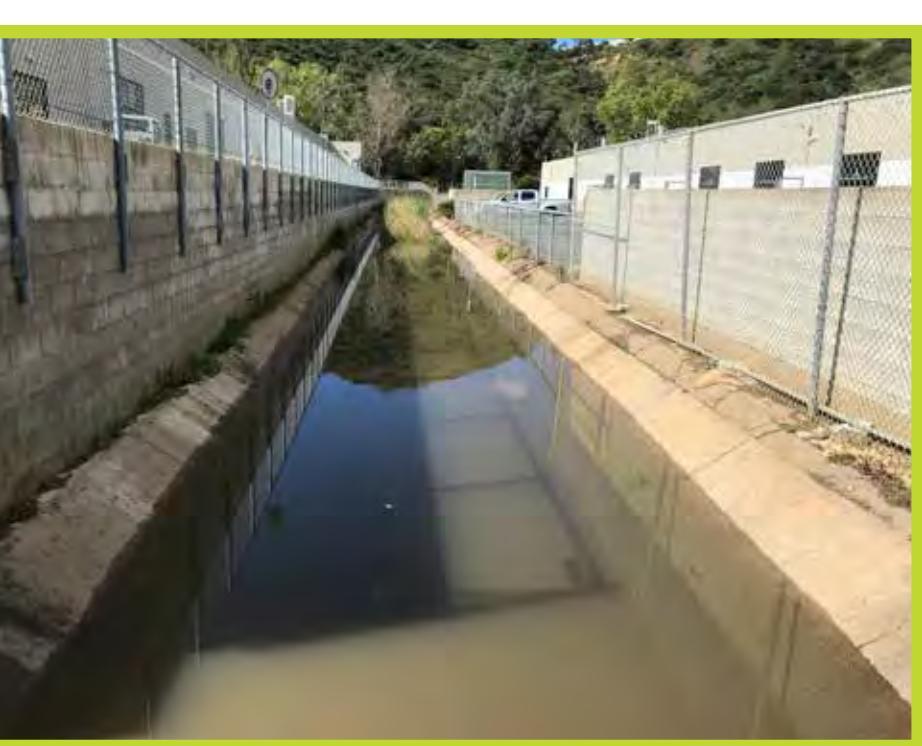
Vegetation at the end of the channel has caused standing water and flooding near Flinkote Avenue.

The concrete channel near Flinkote Avenue needs to be maintained and to remove vegetation that is clogging the channel and causing undesirable standing water even during dry weather (as shown). During rainfall, the channel often floods into the adjacent properties. The clearing of this channel is anticipated to be conducted in FY2022 if funded during the annual budget process.

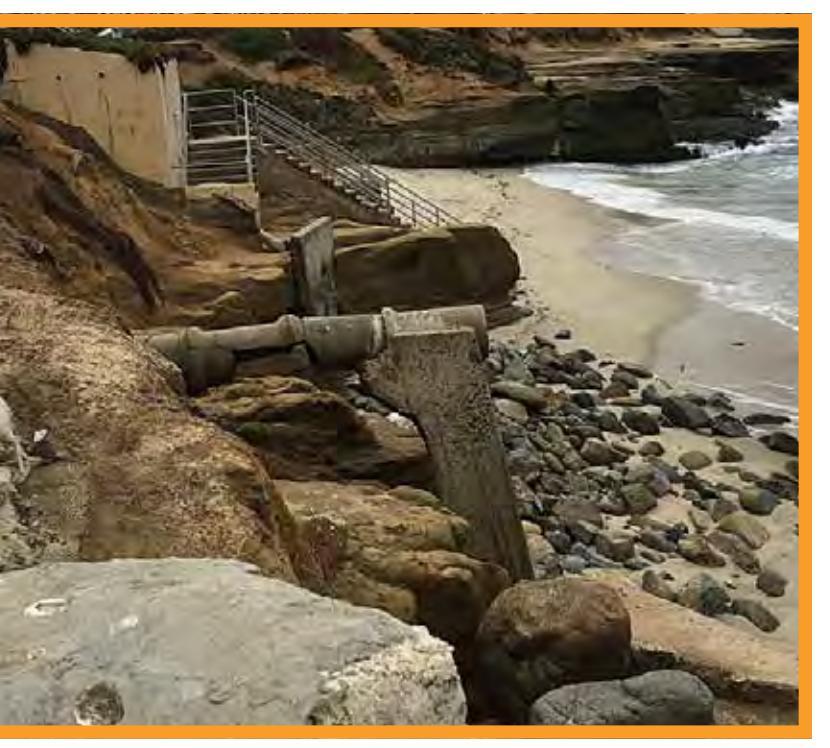
*The broken pipe near the Children's Pool Lifeguard station causes* erosion and poses a public safety risk.

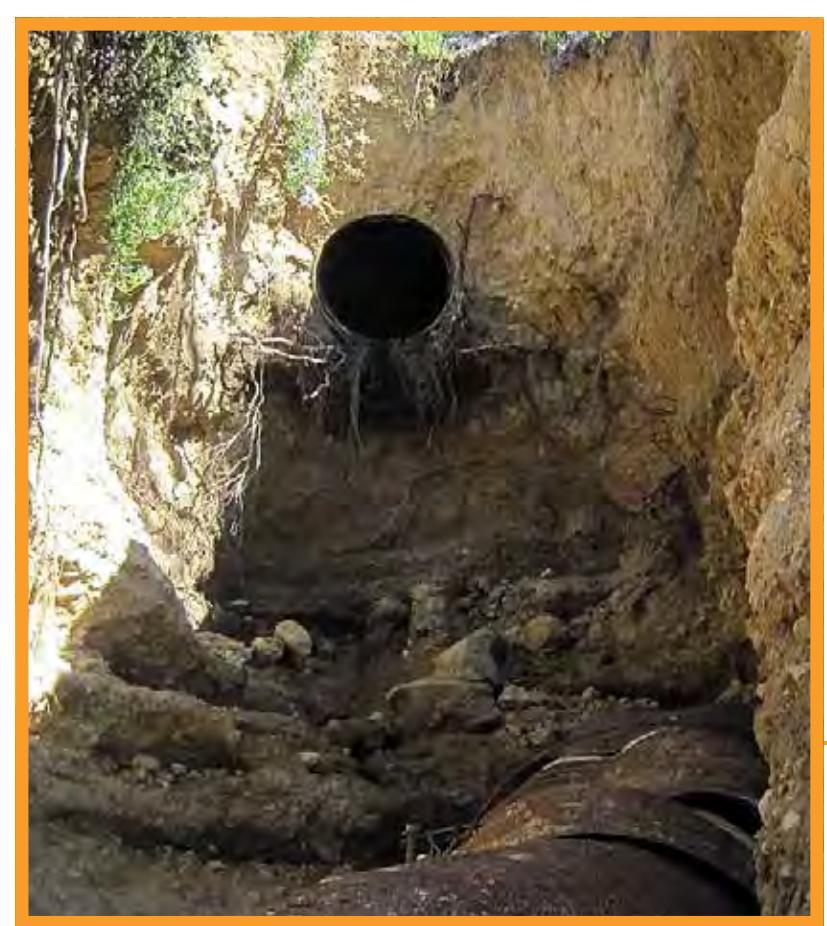
A completely detached storm drain pipe along Sioux Avenue is causing significant erosion.

A pipe has broken and completely separated in the canyon adjacent to Sioux Avenue. The pipe failure has caused significant erosion along the slope, which if left unaddressed will continue to move towards adjacent homes.

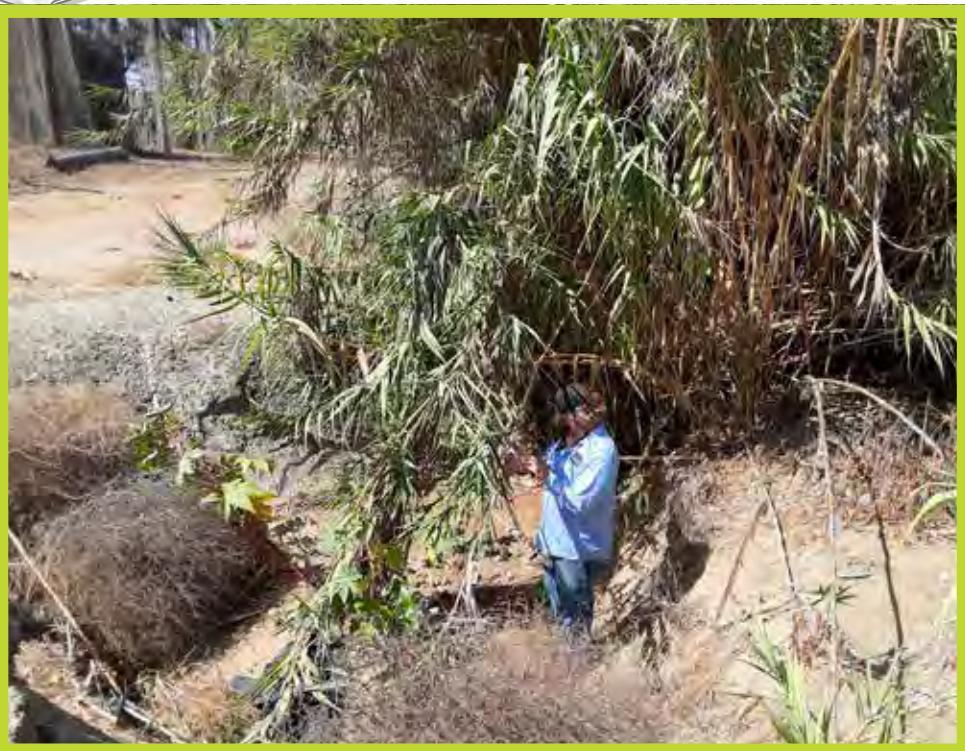
Overgrown and dense vegetation has caused unwanted standing water and flooding (see SWD team member for scale).

This channel is located in Mission Bay Golf Course and is adjacent to Mission Bay Drive. Dense vegetation and sediment deposition are present in the channel and restricts the passage of water and causes flooding. This project will be maintained as an emergency project in FY2021.

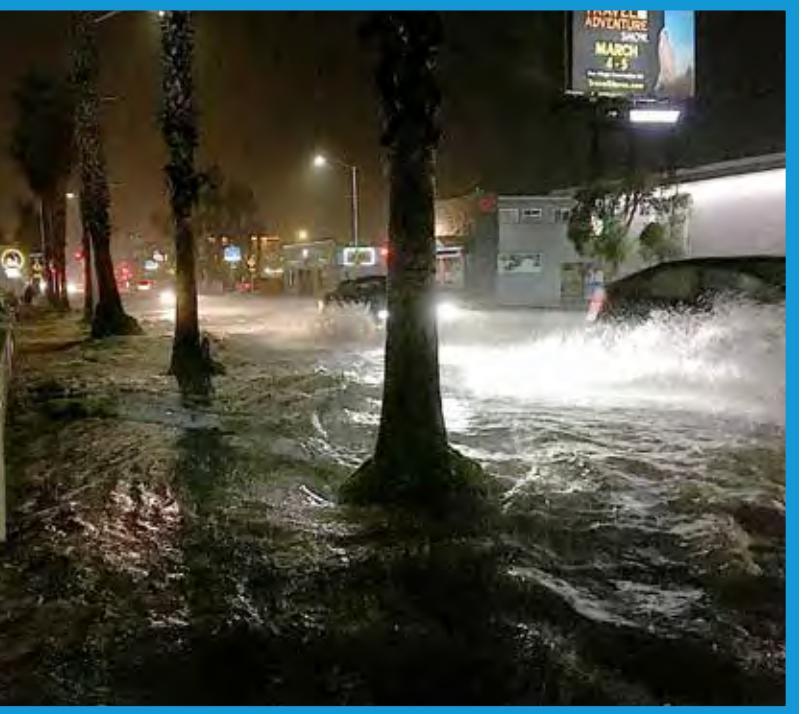
The existing storm drain system near the intersection of Mission Boulevard and Grand Avenue needs to be increased in size to reduce the chance of flooding that currently occurs during rain events. The flooding poses a public safety risk when driving, walking, or biking and often enters nearby properties.

Flooding during rainfall at Mission Boulevard and Grand Avenue causes unsafe conditions for vehicles and pedestrians and often impacts nearby properties.

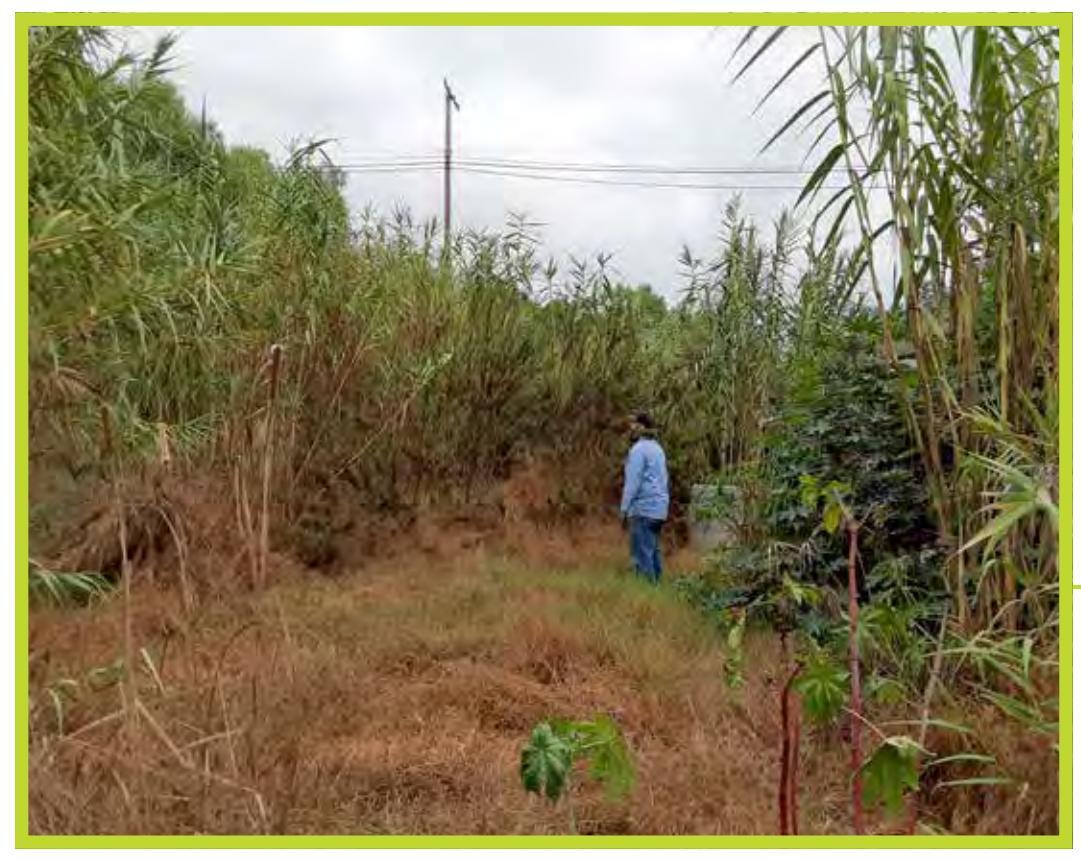
Overgrown and dense vegetation in the channel near West Washington Street restricts capacity and needs to be removed.

Channel maintenance is needed along West Washington Street in Mission Hills where two channel degradation segments will be maintained as one project. There are some structural concerns related to cracked concrete due to tree roots. In addition, dense and overgrown vegetation and sediment deposition are present in the channel and restrict the passage of water and cause flooding. This project will be maintained in FY2021.

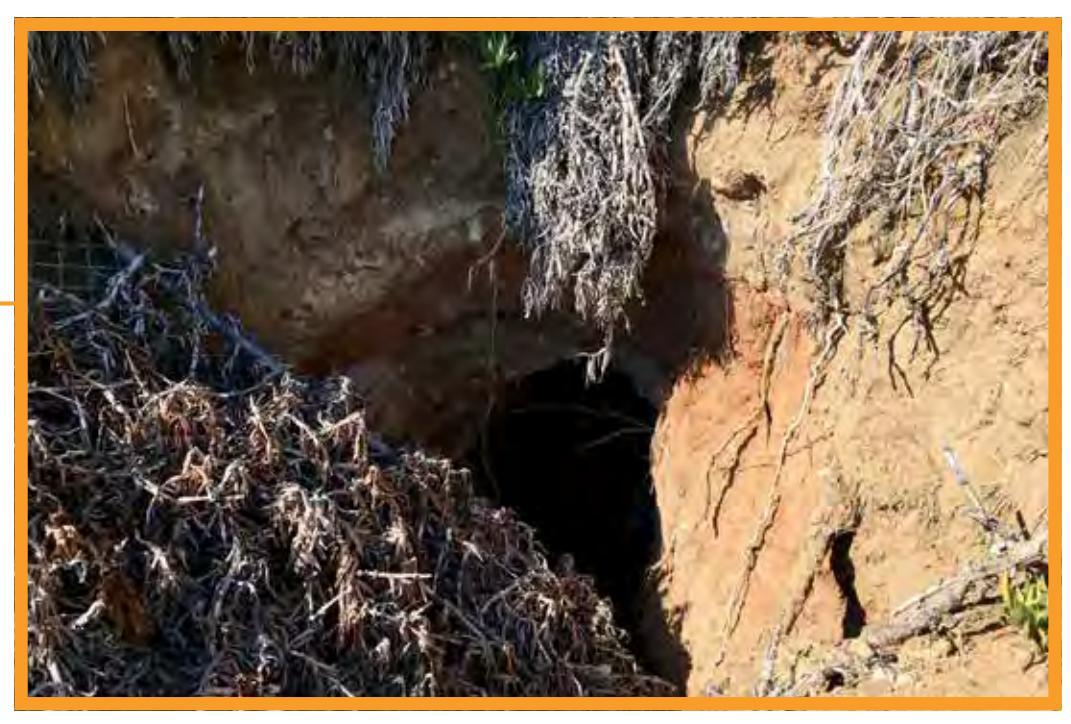
A 25-foot portion of pipe along Kite Street has failed and separated from the downstream system at Jackdaw Street. The resulting flooding has caused erosion, slope failure and a sinkhole downstream. Bypass pumps have been operated at this location since March 2018. The permanent upgrade at this location has been fully designed; however, the project remains unfunded for construction.

Pipe failure has caused erosion and slope failure directly adjacent to residential properties

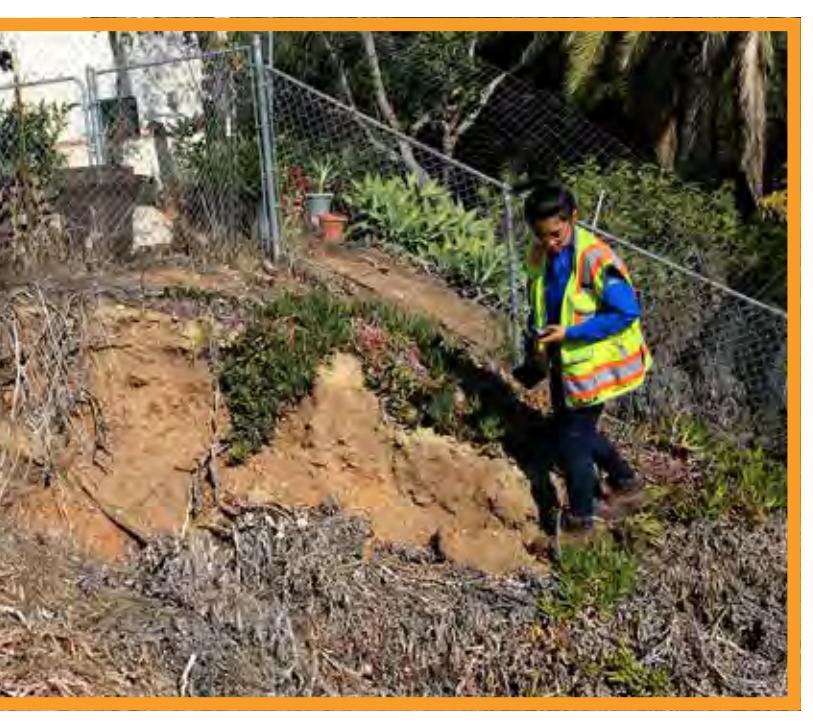
Pipe failure has caused a sinkhole and separation of drainage from the downstream system.

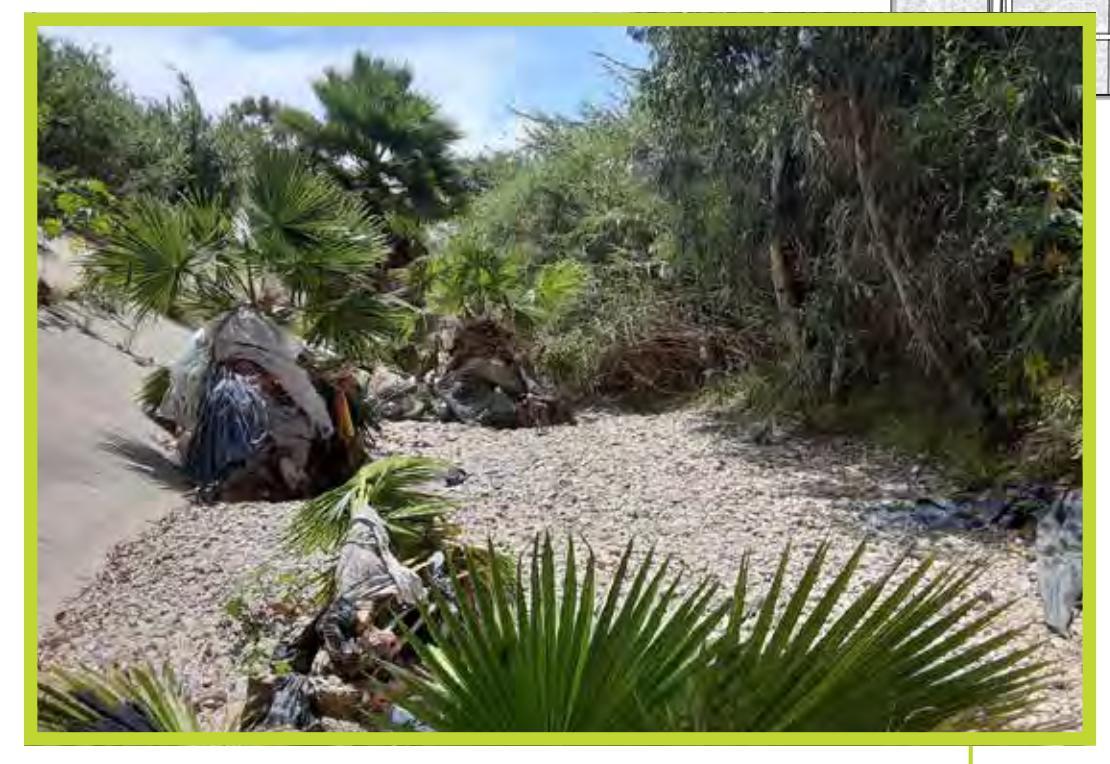
Invasive vegetation in the channel restricts the passage of water and causes accumulation of trash and debris.

Channel maintenance is needed in Chollas Creek between Imperial Avenue and Inland Freeway to remove vegetation and accumulated sediment, trash, and debris. Portions of the channel have cracking concrete due to tree roots, while other sections are earthen and have visible erosion due to high velocity flows. Maintenance and repair of this channel is anticipated in FY2023 if funded during the annual budget process.

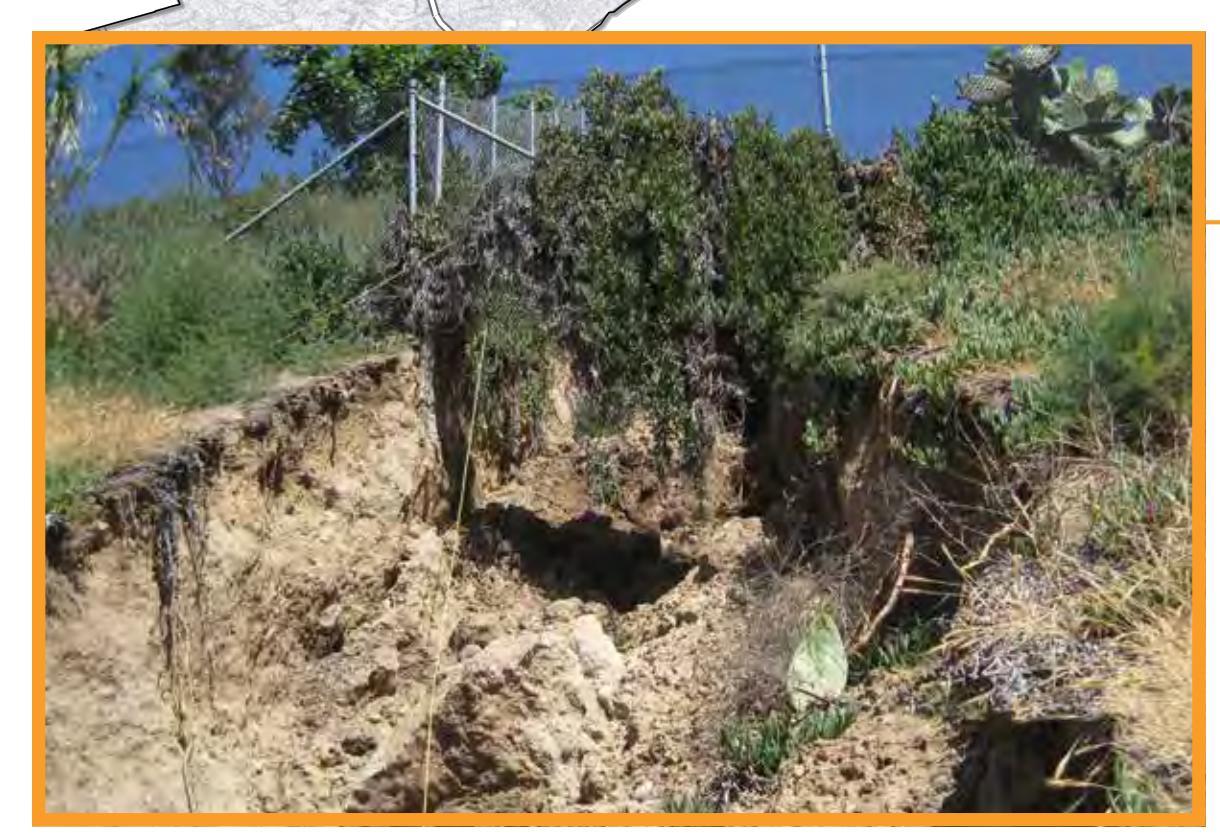
Pipe failure at behind Prairie Mound Way has caused erosion and slope failures.

Failure of a storm drain pipe behind Prairie Mound Way has caused slope failure along private property. The excess stormwater that flows down this slope due to the storm drain failure also has the potential to impact the stability of a downstream closed County of San Diego landfill. Bypass pumps have been operated at this location since September 2017 to reduce flows at this location. Permanent upgrades remain unfunded.

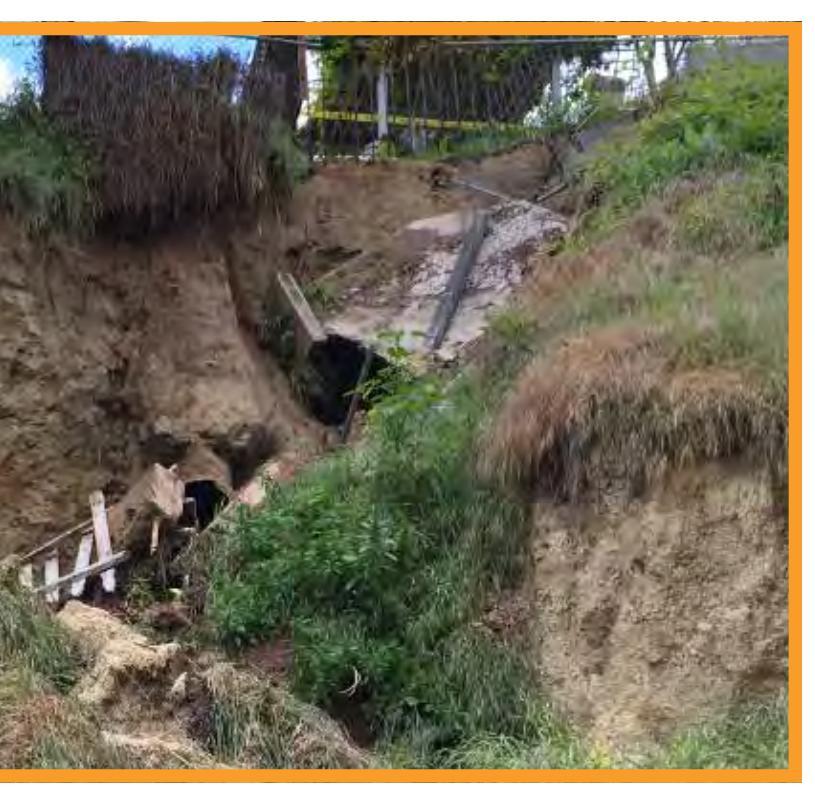
An 18-inch storm drain pipe has failed along the downward slope behind Ava Street and could continue to impact the stability of the slope if not replaced. This location has been on the Stormwater Department priority project list since April 2020 but currently remains unfunded.

The failed storm drain near Ava Street has caused erosion and collapse of slopes that pose a safety risk.

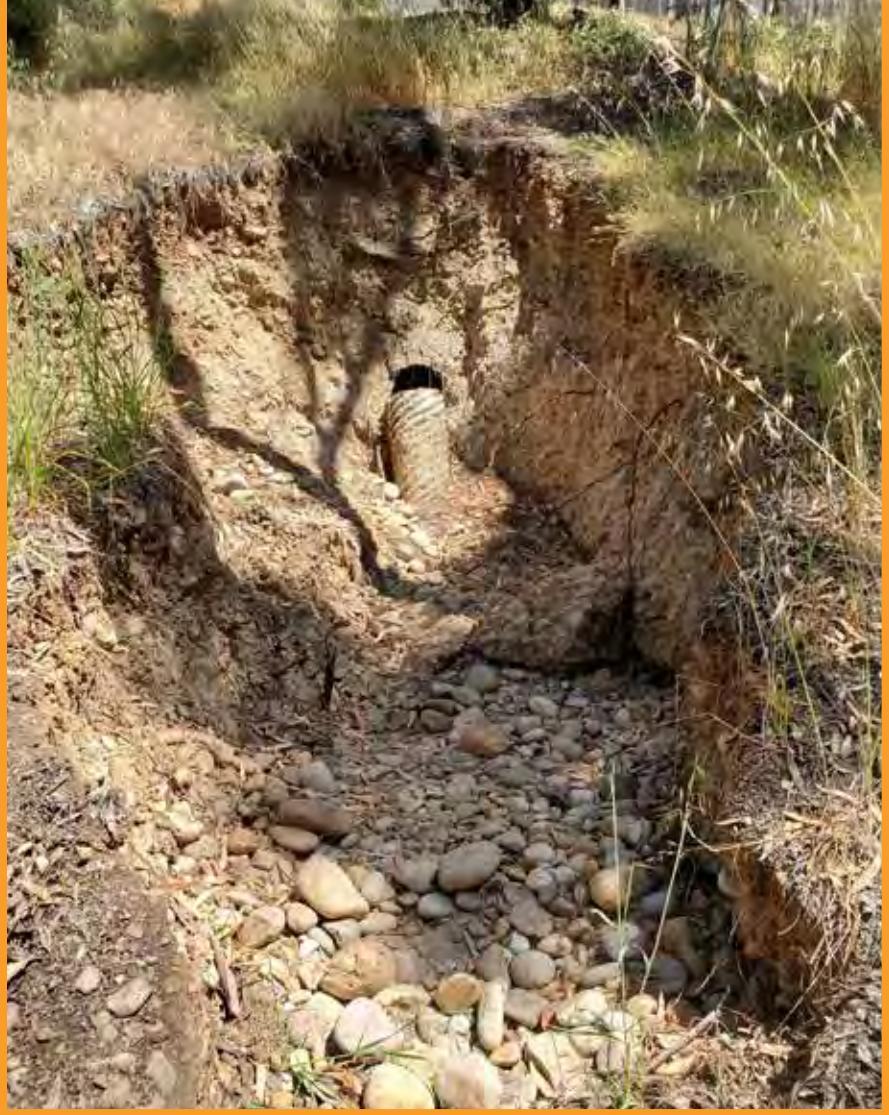
The collapsed storm drain behind Negley Avenue has caused slope failure and poses a public safety risk.

An 18-inch storm drain pipe has failed at two different locations along the downward slope behind Negley Avenue. This impacted slope has caused instability to the surrounding area, including to the public park trail system in the canyon below the failure. This location has been on the Stormwater Department priority project list since May 2020 but currently remains unfunded.

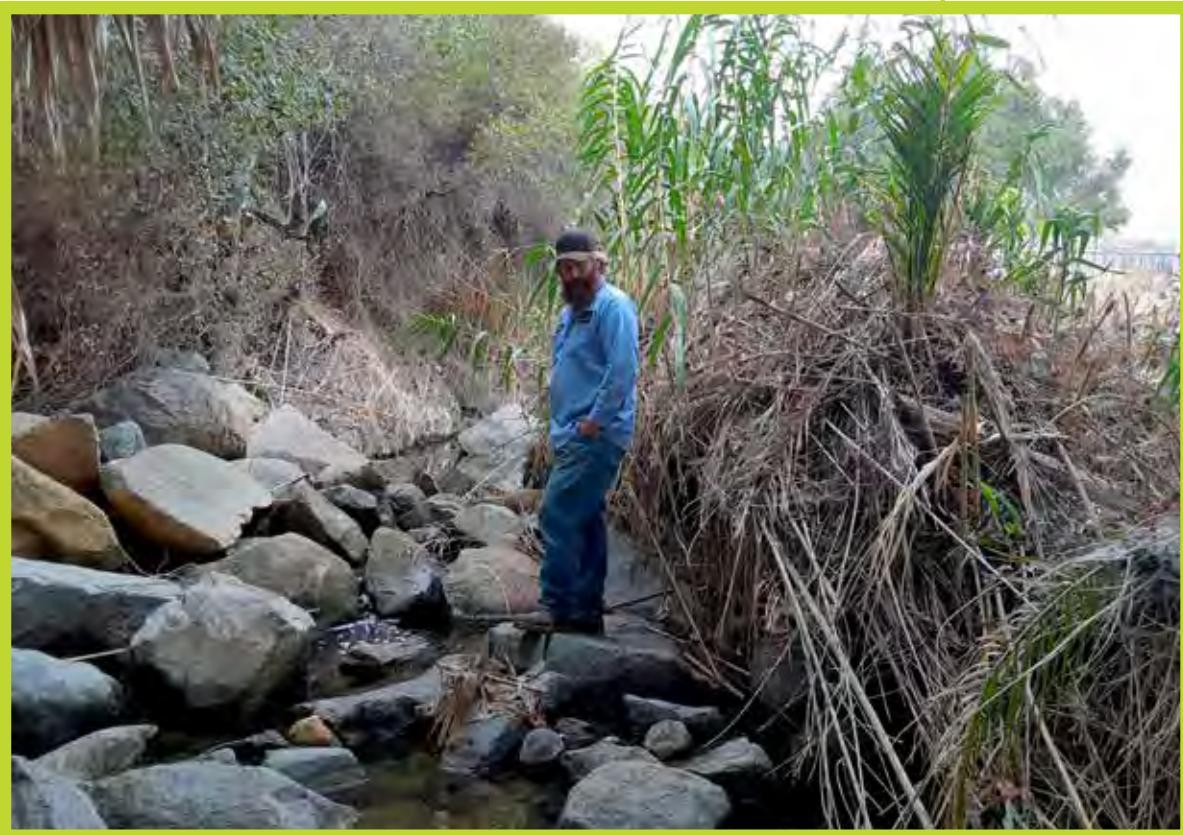
Channel maintenance is needed in Tecolote Creek along Genesee Avenue to remove vegetation and accumulated sediment, trash, and debris that may cause flooding downstream. In addition, the culvert at the upstream portion has a failed pipe that needs to be replaced. Maintenance and repair of this channel is anticipated in FY2022 if funded during the annual budget process.

Dense vegetation as shown on the right side of the Channel along Genesee Avenue restricts the passage of water and causes accumulation of trash and debris.

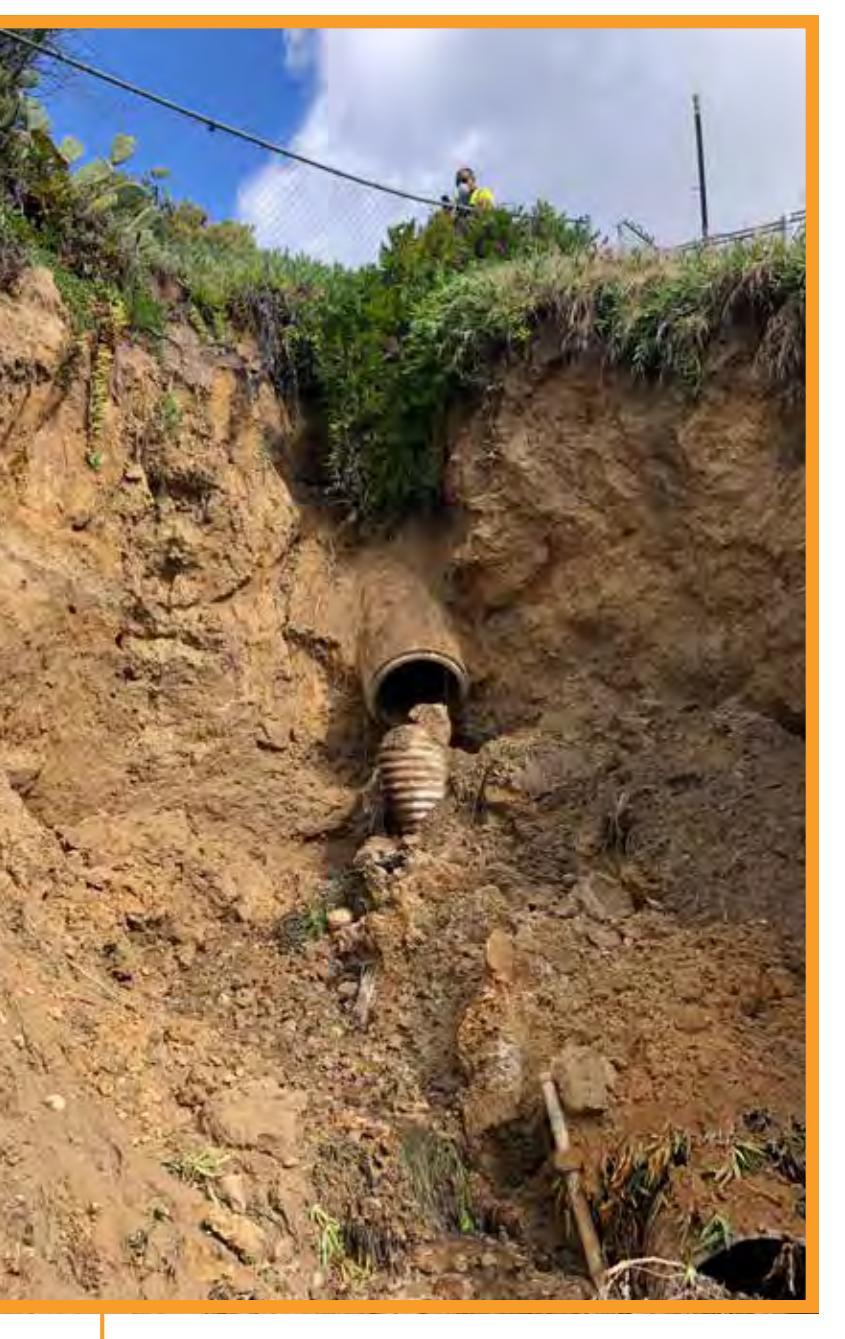
An 24-inch storm drain pipe has failed along the downward slope behind Argonne Court and could continue to impact the stability of the slope and the adjacent areas. This location has been on the Stormwater Department priority project list since April 2020 but currently remains unfunded.

The collapsed storm drain near Argonne Court has caused slope failure and poses a growing public safety risk.

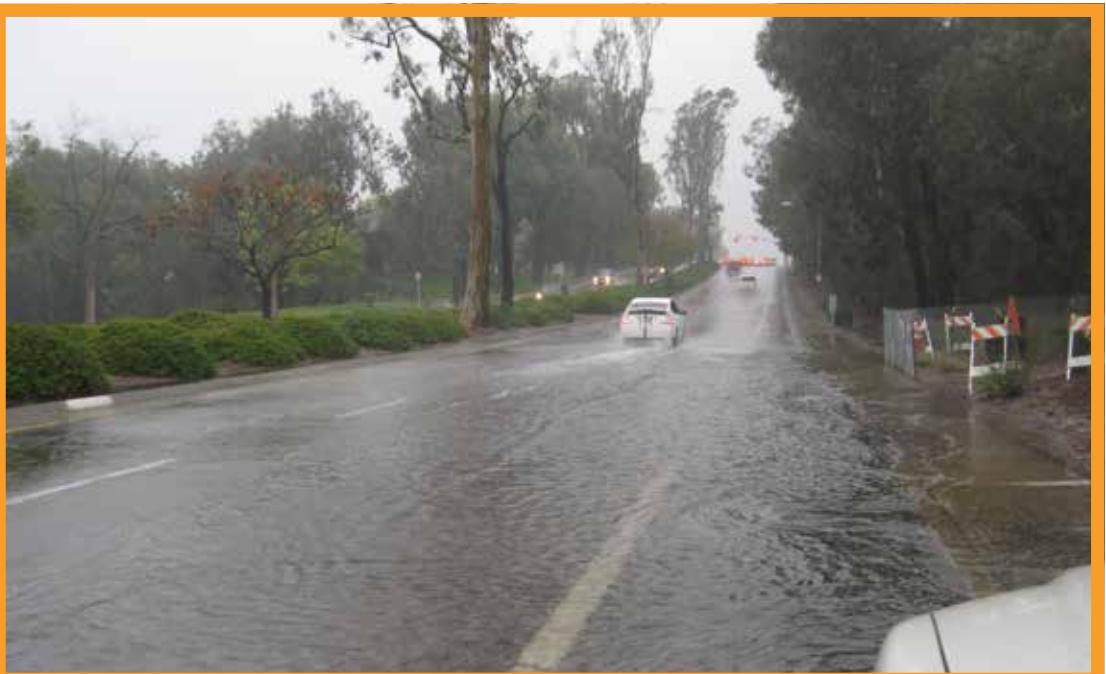
Pipe failures along Clairmont Mesa Boulevard causes flooding during rain events that runs off of the side of the road and causes significant erosion.

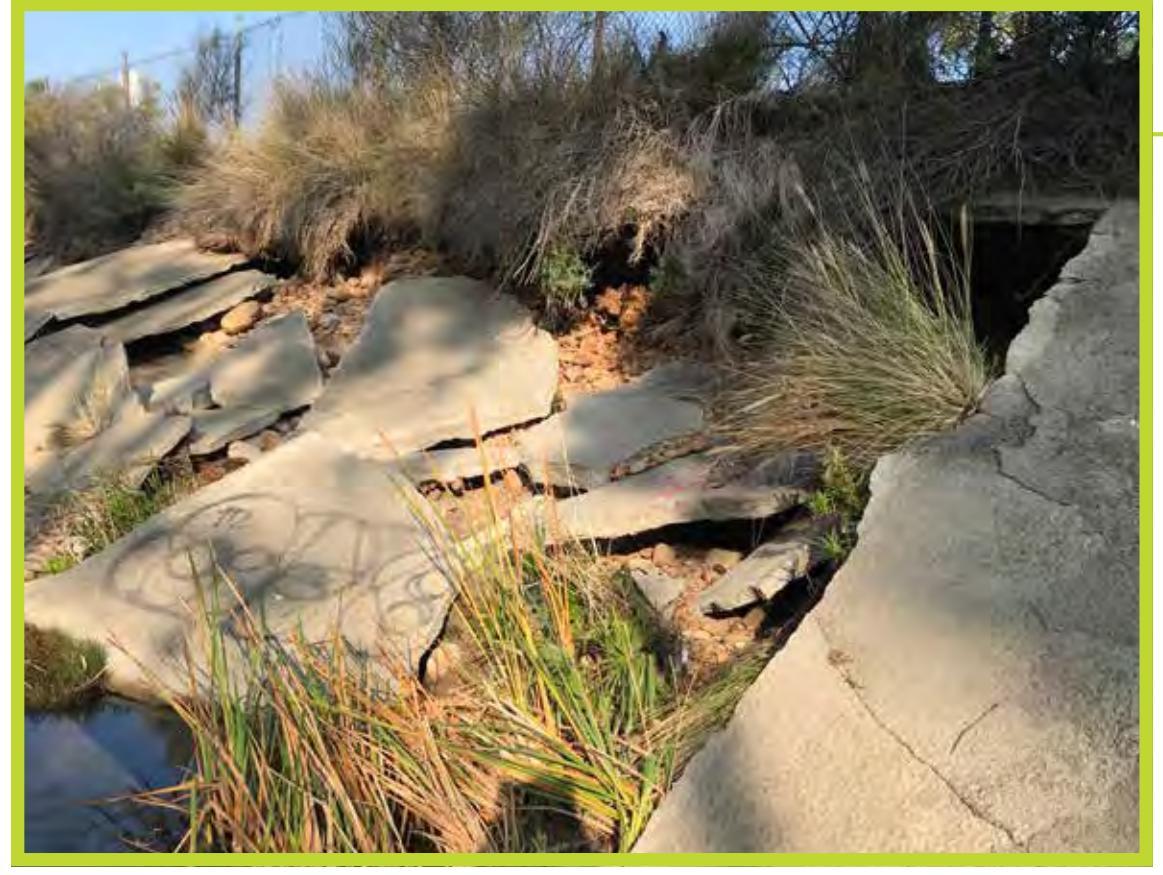
Broken concrete on the banks of Alvarado Canyon Creek needs to be repaired.

Channel maintenance is needed along Alvarado Canyon Creek near Mission Gorge Road to repair broken concrete at numerous locations along the channel banks. Invasive vegetation also needs to be removed to reduce the chance for flooding. This project, which consists of two channel degradation segments, will be maintained in FY2021.

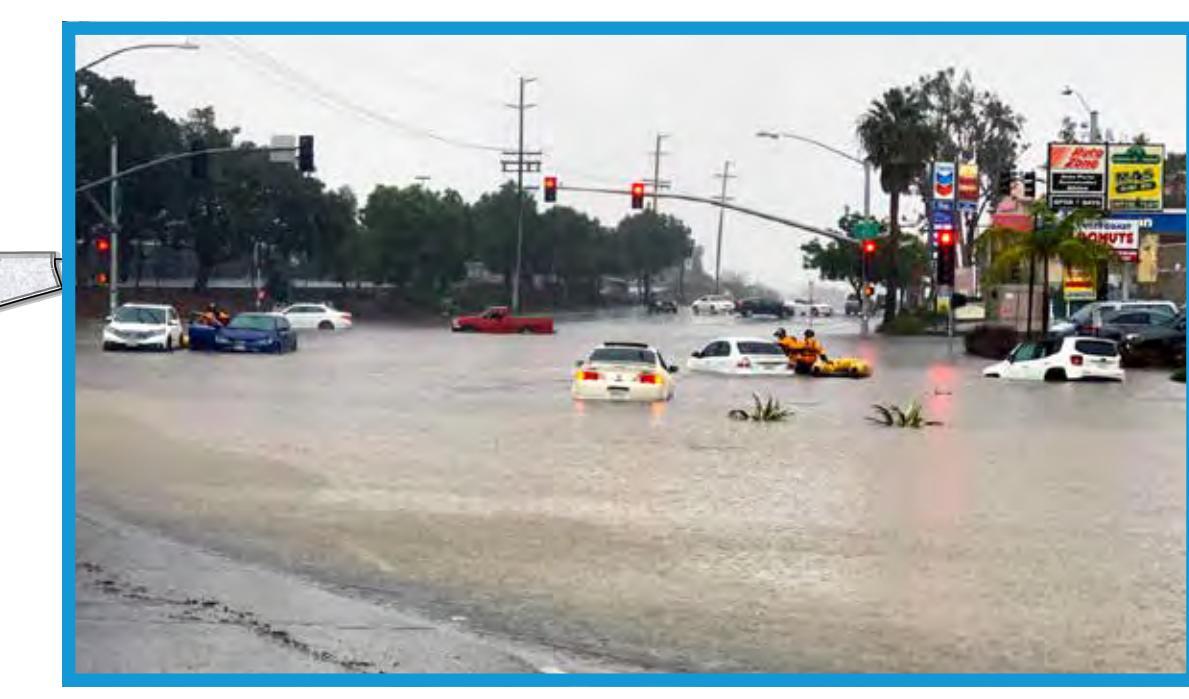
Insufficient drainage at Palm Avenue and Beyer Boulevard causes significant flooding and is a public safety risk.

The existing storm drain system near Palm Avenue and Beyer Boulevard is undersized and causes flooding at the intersection and surroundings during rain events. Upgrades of the storm drain system are needed to prevent impacts to transit and nearby businesses.

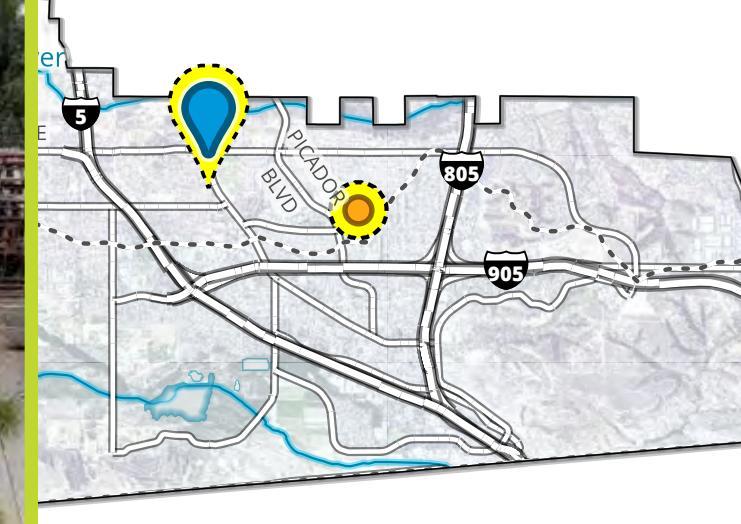
Channel maintenance is needed near National Avenue to repair broken concrete at numerous locations along the channel banks. Invasive vegetation and sediment also need to be removed to improve flow capacity at this location, which has a history of flooding. This project is not currently funded.

Broken concrete on the banks of the channel near National Avenue needs to be repaired.

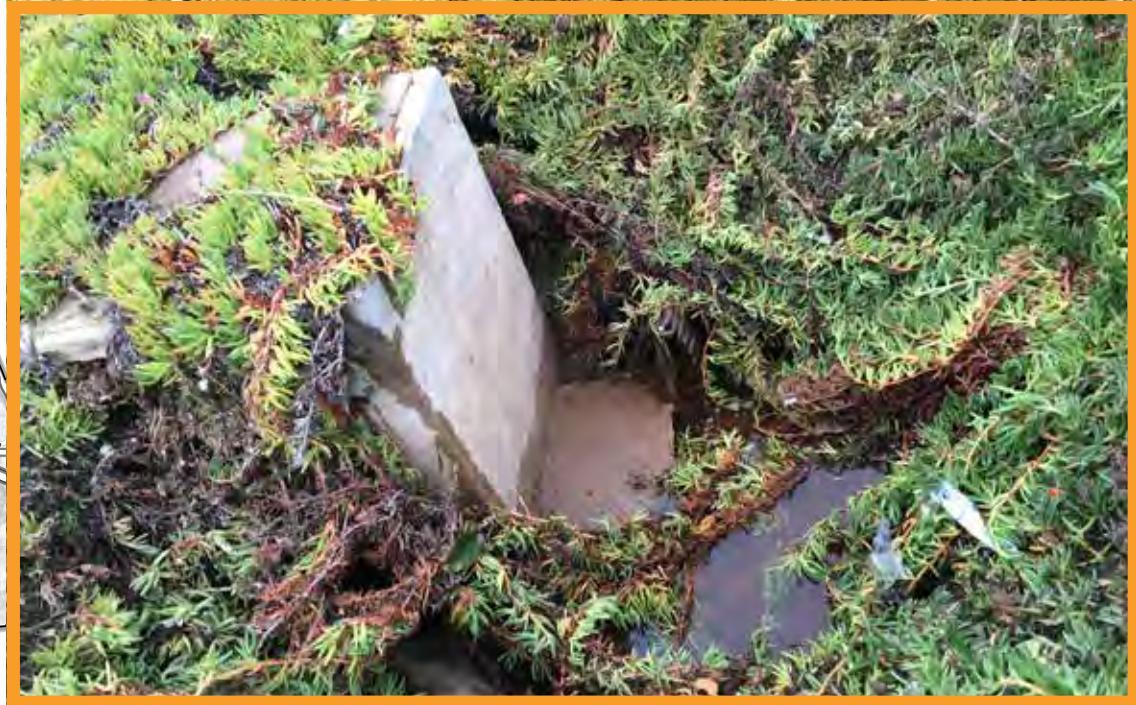
The existing storm drain pipe has failed along the slope at Aqua Park Court. As a result, stormwater currently discharges along the slope and down into the adjacent area and has the potential to cause flooding. Stormwater improvements at this location have been needed since December 2019 and are not currently funded.

Pipe failure has caused stormwater to bypass the stormwater system and causes ponding and potential flooding.

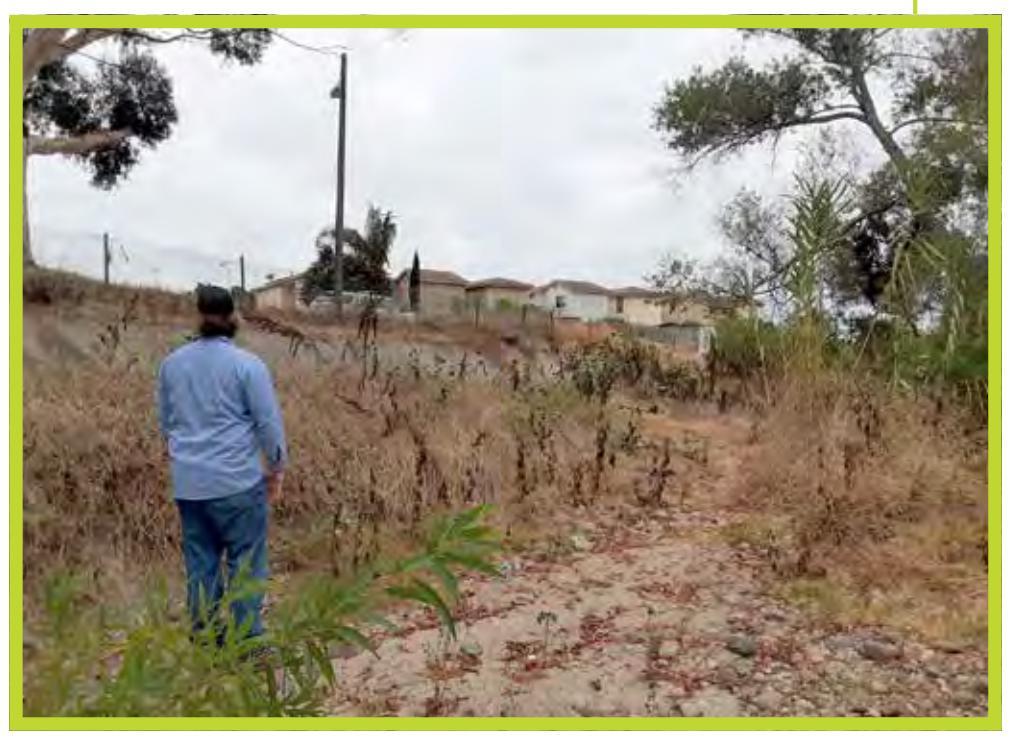
Channel maintenance is needed in South Chollas Creek near Alpha Street to remove significant sediment accumulation and vegetation, which can lead to flooding. This channel has been a priority maintenance location for the Division since 2018; however funding and environmental permit limitations have resulted in postponement. The clearing of this channel is anticipated to be conducted in FY2022 if funded during the annual budget process.

Significant sediment deposition and overgrown vegetation restrict channel capacity in South Chollas Creek.
