## **COMMUNITY FLOOD ASSESSMENT** WHAT IS AT RISK IN FISCAL YEAR 2021?

# **COUNCIL DISTRICT 1: FISCAL YEAR 2021 COMMUNITY FLOOD ASSESSMENT**

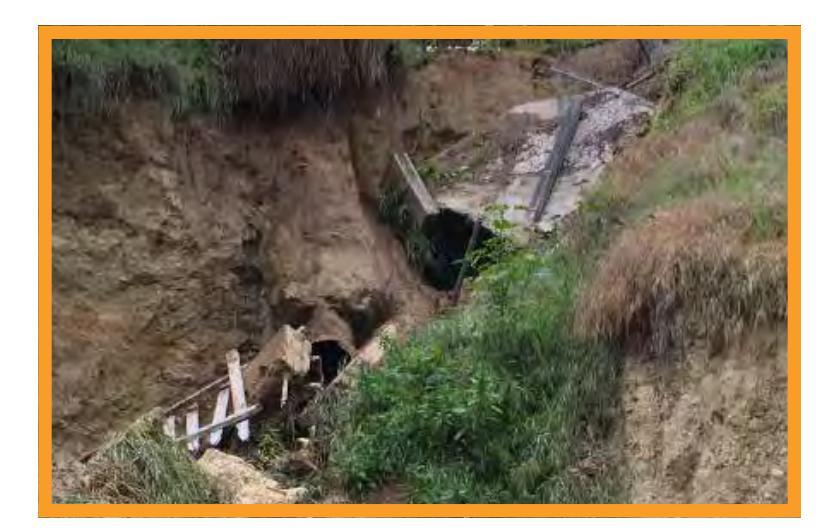
#### • 1832 Pipe Failures Locations

These locations represent stormdrain pipes that have been damaged or have degraded to a condition that requires replacement. Pipe failures can lead to community safety risks like flooding, sinkholes and slope failures.

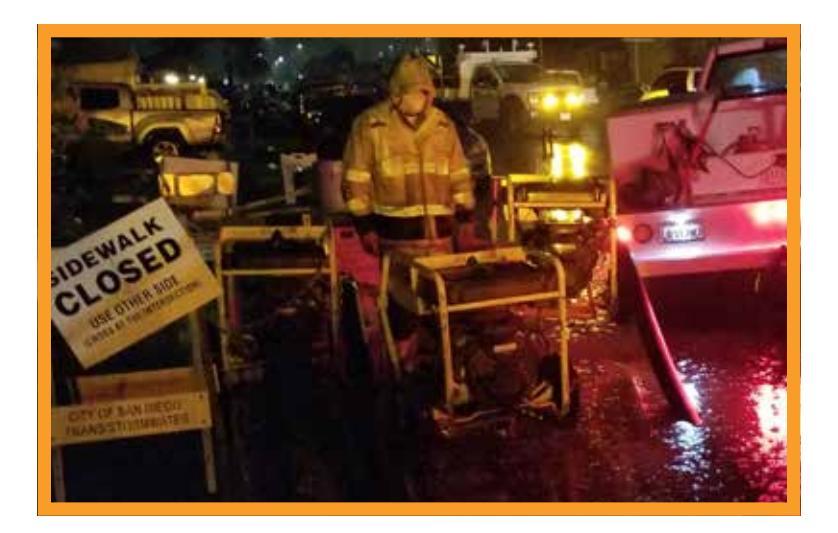
#### **Q** 24 Pipe Failure Bypass Locations

During rain events, Stormwater Division staff operate mobile bypass pumps at certain pipe failure locations as a temporary mitigation measure due to funding being unavailable to permanently repair or upgrade the pipe. These bypasses are necessary to decrease flooding impacts and reduce chance for larger scale failures in the surrounding infrastructure and community. Over the long term, operating these "band aid" solutions both diverts resources from other priorities and is more expensive than fixing the failure in the first place.

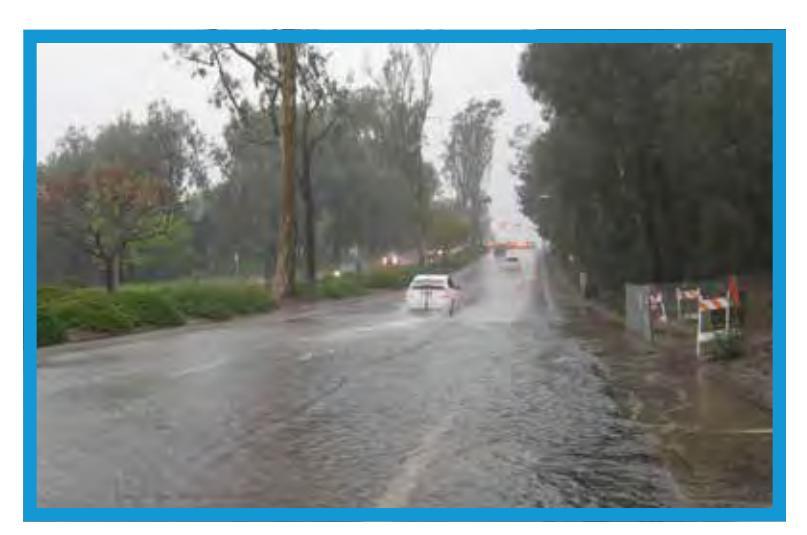
#### 49 Flooding Locations - Surface Drainage

These locations experience flooding due to surface drainage issues – some causes include current infrastructure that is undersized, the need for new infrastructure, or roads that have been paved over and do not have sufficient capacity in the curb and gutter system to minimize flood risk.

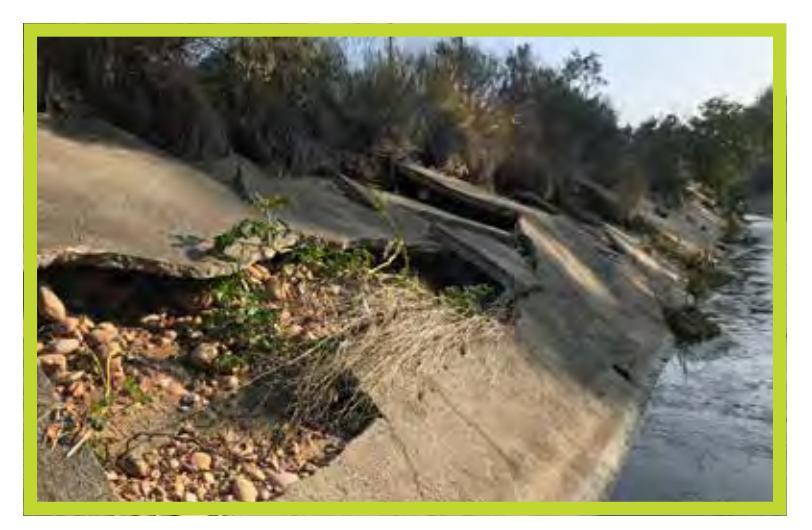
#### **68** Channel Degradation Locations

These locations represent the priority channels identified over the past three years (FY2018-FY2020) as needing maintenance or repair to reduce the risk of failure and impacts to the surrounding community. The Stormwater Division may need to remove invasive or overgrown vegetation, clear accumulated sediment and trash, repair holes or failures in the channels, or address erosion.

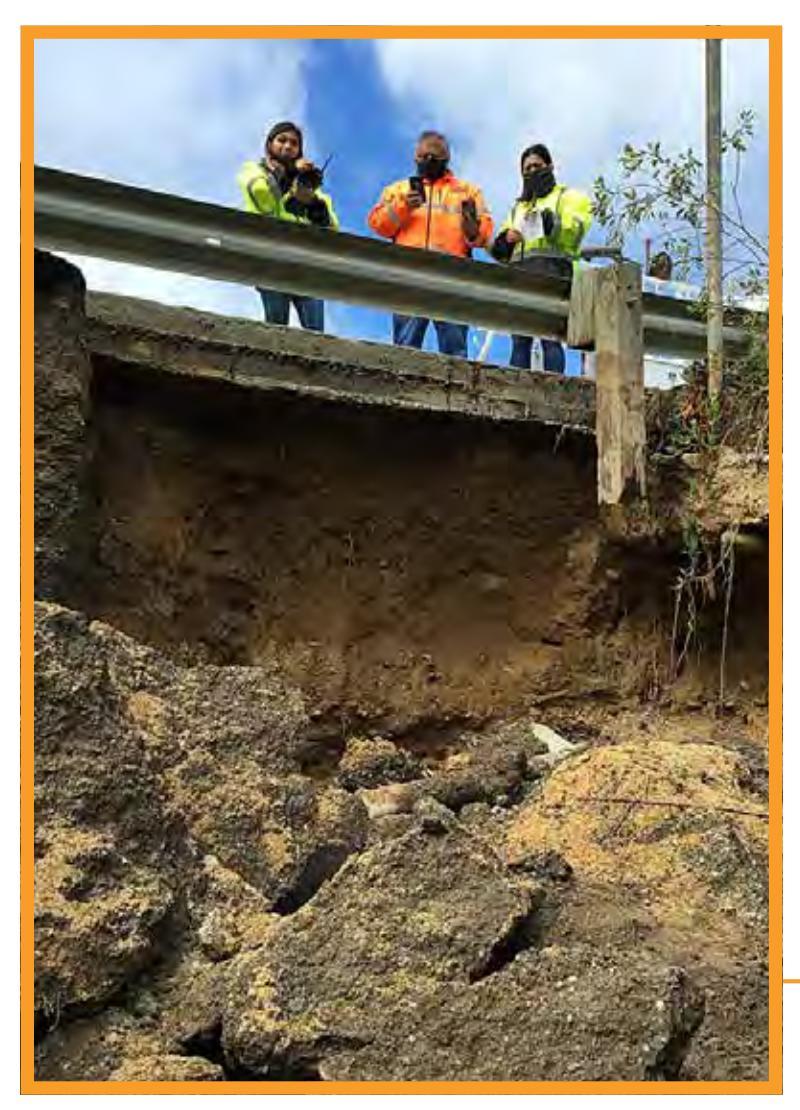
Pipe failures and achannel degradation location have caused flooding and slope failures along La Jolla Scenic Drive.

The stormwater system near La Jolla Scenic Drive has three pipe failures and a channel degradation location that has caused flooding, erosion, and slope failures along the roadway and offramp that pose a public safety risk.

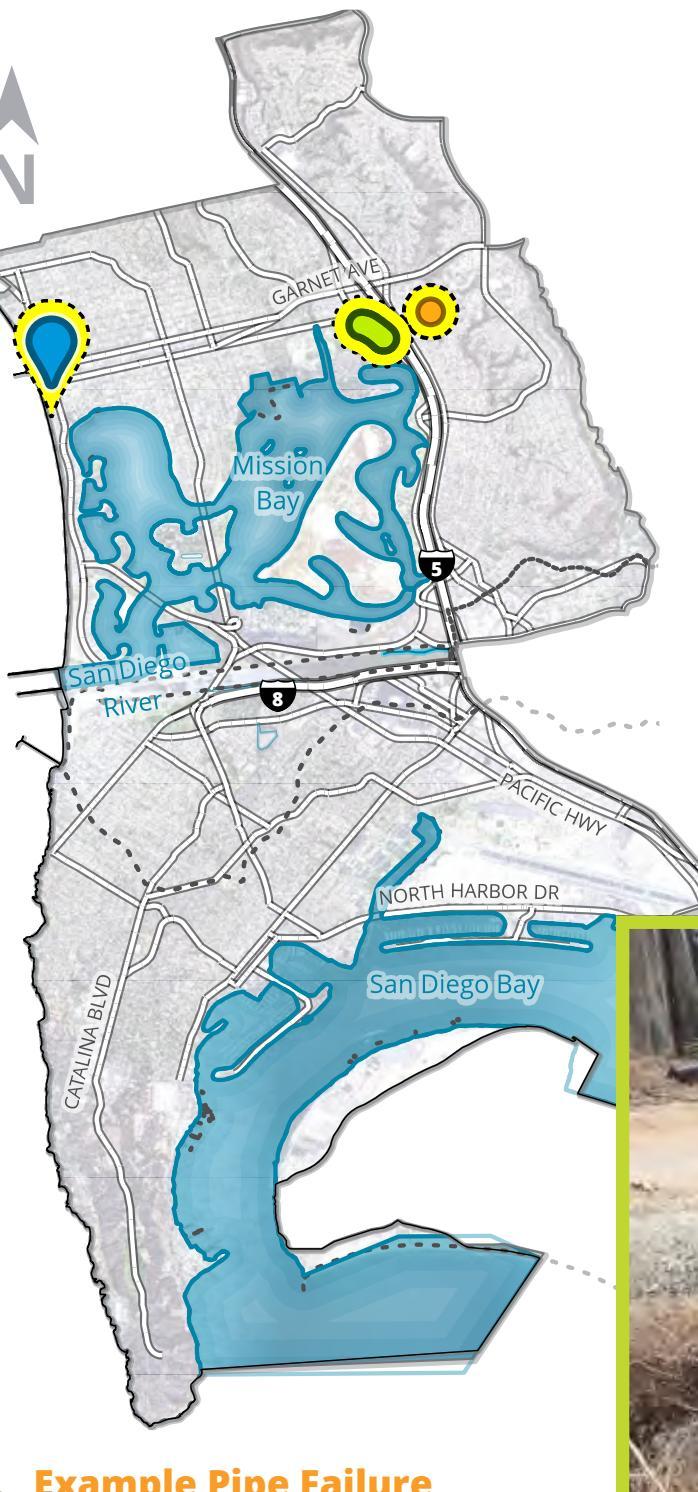
### Example Flooding -Surface Drainage Location

The existing storm drain system near the intersection of Mission Boulevard and Grand Avenue needs to be increased in size to reduce the chance of flooding that currently occurs during rain events. The flooding poses a public safety risk when driving, walking, or biking and often enters nearby properties.

Flooding during rainfall at Mission Boulevard and Grand Avenue causes unsafe conditions for vehicles and pedestrians and often impacts nearby properties.

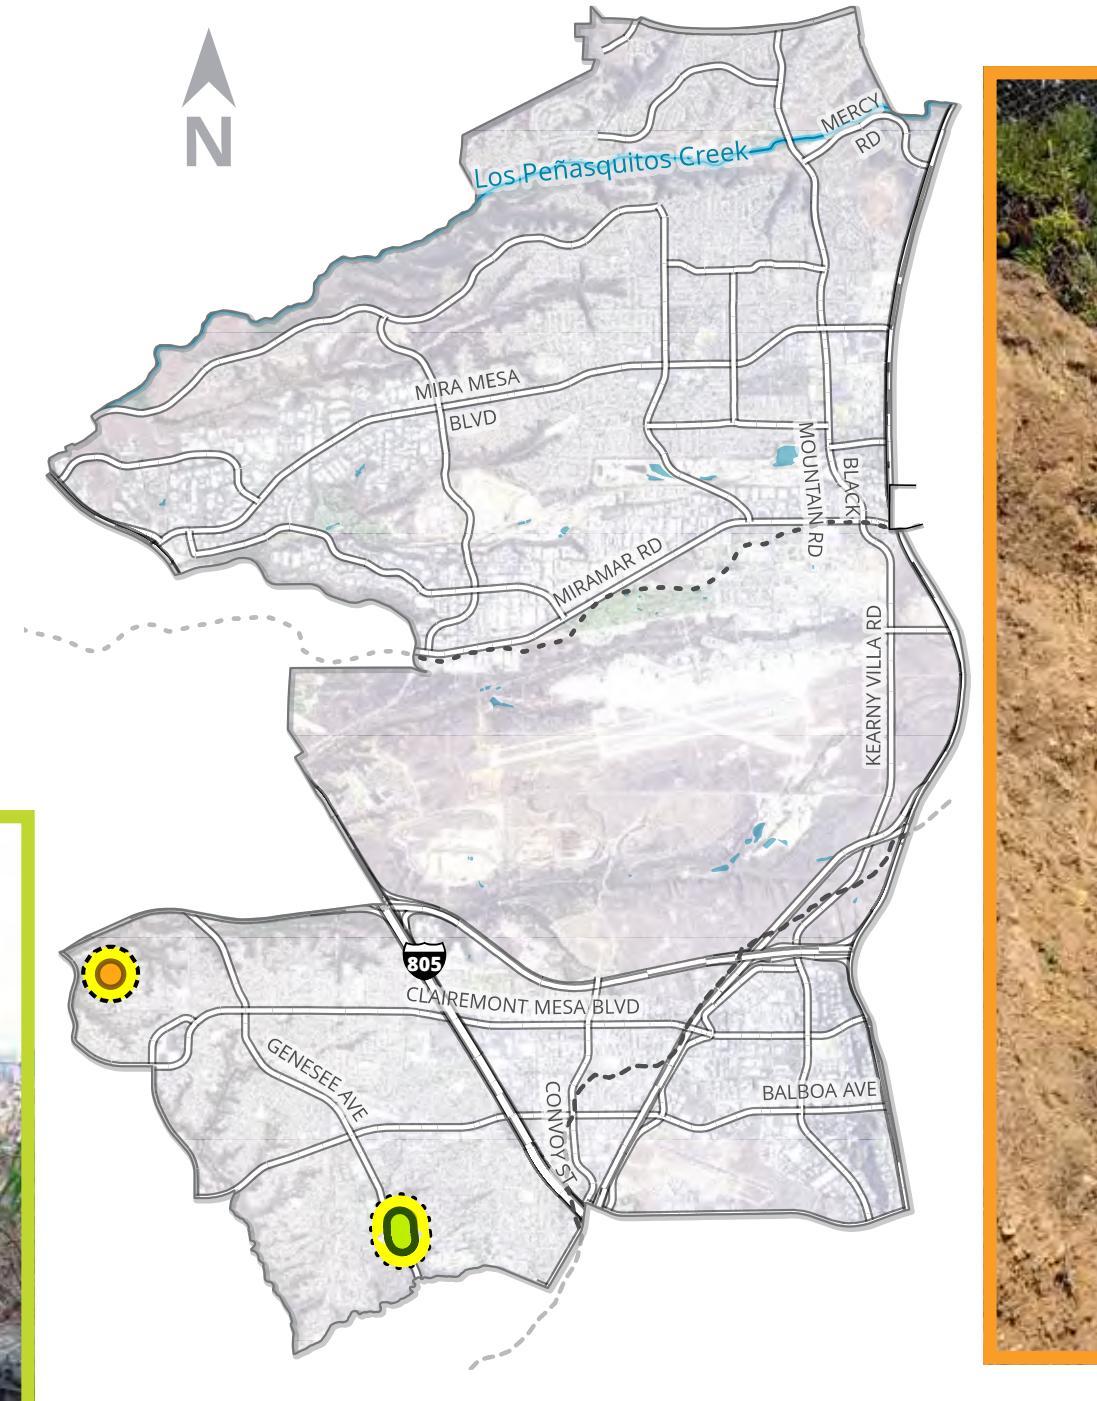
#### • Example Pipe Failure Location

An 24-inch storm drain pipe has failed along the downward slope behind Argonne Court and could continue to impact the stability of the slope and the adjacent areas. This location has been on the Stormwater Department priority project list since April 2020 but currently remains unfunded.
